ANNEX 4 – Vacuum Units

Annex 4.1 - General Information

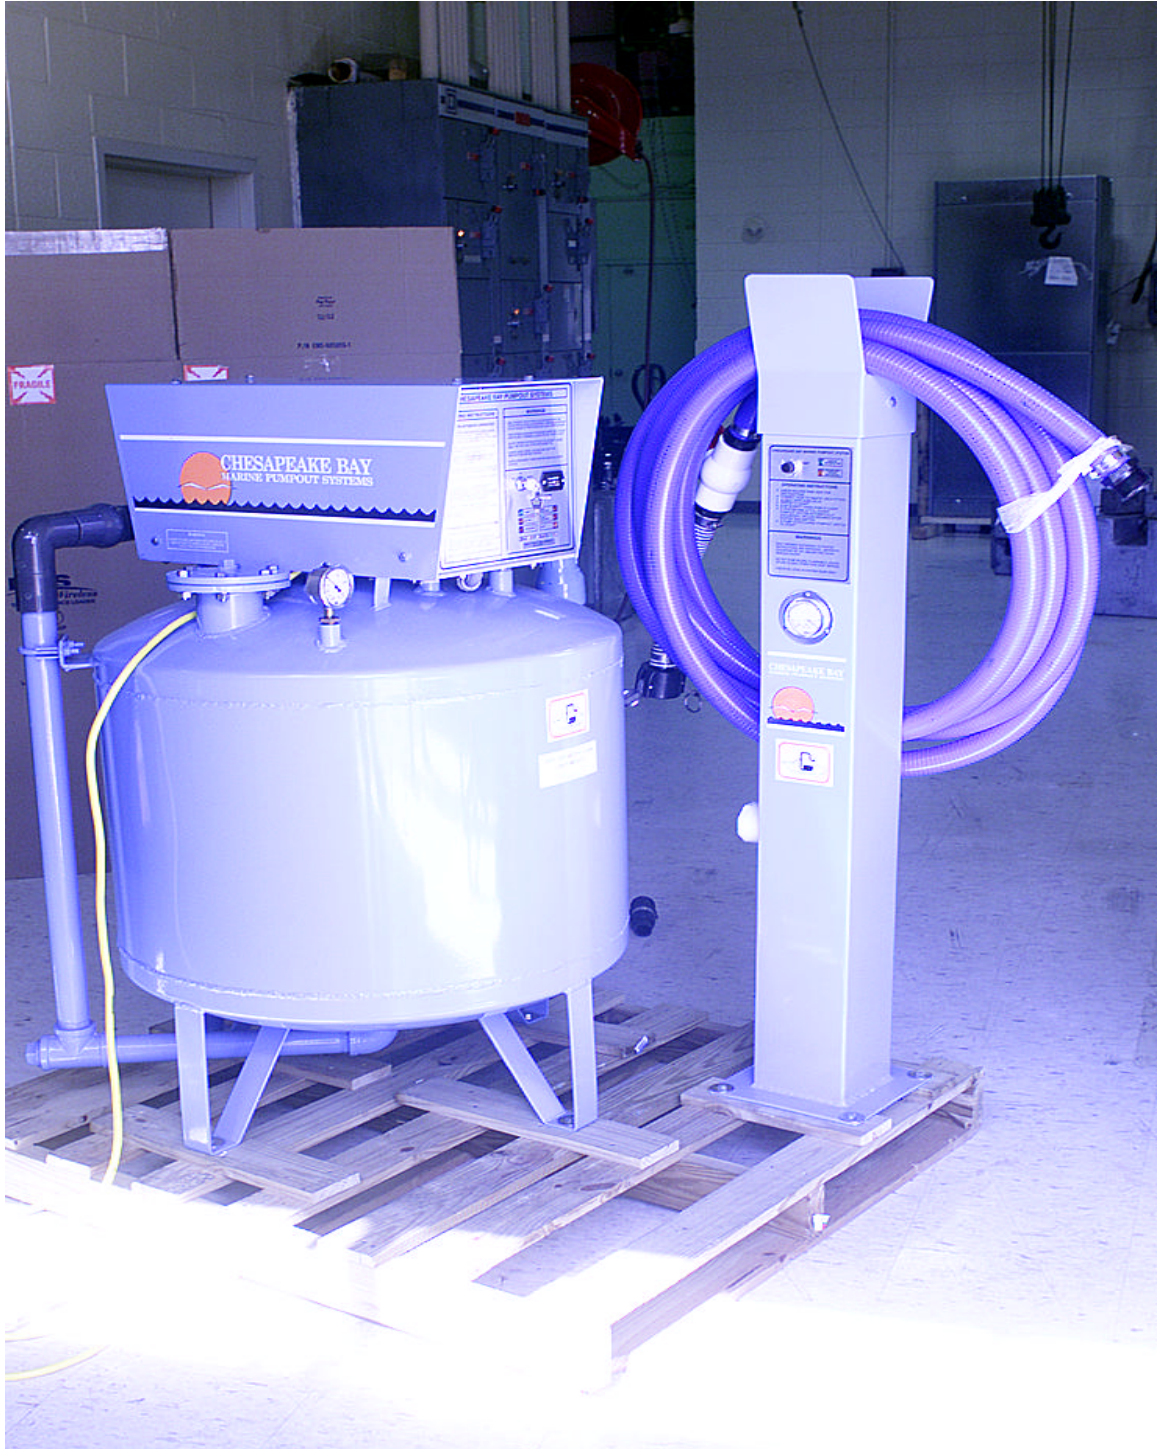
Unit Photograph

The Chesapeake Bay Marine Pump-Out unit operated for the full 1000 hours in the life-cycle testing set-up. During the first 38.8 hours of operation in the life-cycle testing setup, this unit exhibited problems with frequently blowing the internal fuse for the vacuum pump and tripping of the unit circuit breaker. A representative of Chesapeake Bay Marine made a site visit to troubleshoot problem with unit. When the vacuum pump was disassembled for troubleshooting, unusual deposits were found in the internals of the pump and in the air discharge manifold of the pump. After consultation with the manufacturer, it was decided that these deposits were most likely caused by the lubricating oil overheating in the vacuum pump; and the resulting break-down of the oil showed up as visible deposits on the internals of the pump and the air discharge manifold. Since the Waubaushene Model AVR60 had a similar vacuum pump produced by the same manufacturer (Gast), the air discharge manifold for the Waubaushene Model AVR60 vacuum pump was inspected to see if it contained similar deposits. No deposits were noted in the Waubaushene Model AVR60. This problem most likely showed up in the Chesapeake Bay Marine unit because the unit utilizes a very low-flow oiler for lubrication. With very small amounts of oil flowing through the vacuum pump, the oil has more time to heat up to a high temperature where it is likely to break-down. The Waubaushene Model AVR60 used an oiler with a higher oil flowrate and this unit did not experience a problem of this type. In order to address the problem with the Chesapeake Bay Marine Vacuum Pump-out unit, another vacuum pump oil (Nu-Calgon Vacuum Pump Oil) was used in this unit during the remaining 961.2 hours of operation and no further problems with the pump was noted.

Note: Because of the lengthy time required to diagnose the lubrication problem, the SOBA representative allowed the Chesapeake Bay Marine unit to be operated beyond the June 4, 2004 cut-off date. The extended operation was allowed on the condition that if the unit continued to shutdown, testing would be halted. Once the Nu-Calgon Vacuum Pump Oil was substituted, the unit continued operation without any further problem.

1. Corrosion Resistance: A sample of the Boilerplate Steel used in constructing the tank and steel mounting legs was subjected to the Salt-Spray Exposure described in *Section 2*. The sample was found to have inferior corrosion resistance on bare surfaces. The powder-coated painted surfaces of the sample exhibited good corrosion resistance. An additional sample of the aluminum Control Unit cover was subjected to the Salt-Spray Exposure described in *Section 2.3* and the sample was found to have superior corrosion resistance.
 2. Ultraviolet Exposure Resistance: This unit did not have any fiberglass or plastic covers, so no ultraviolet exposure testing was performed on this unit.
-

After the lubrication issue on this unit was identified and resolved, no additional repairs were required on the unit during life-cycle testing.

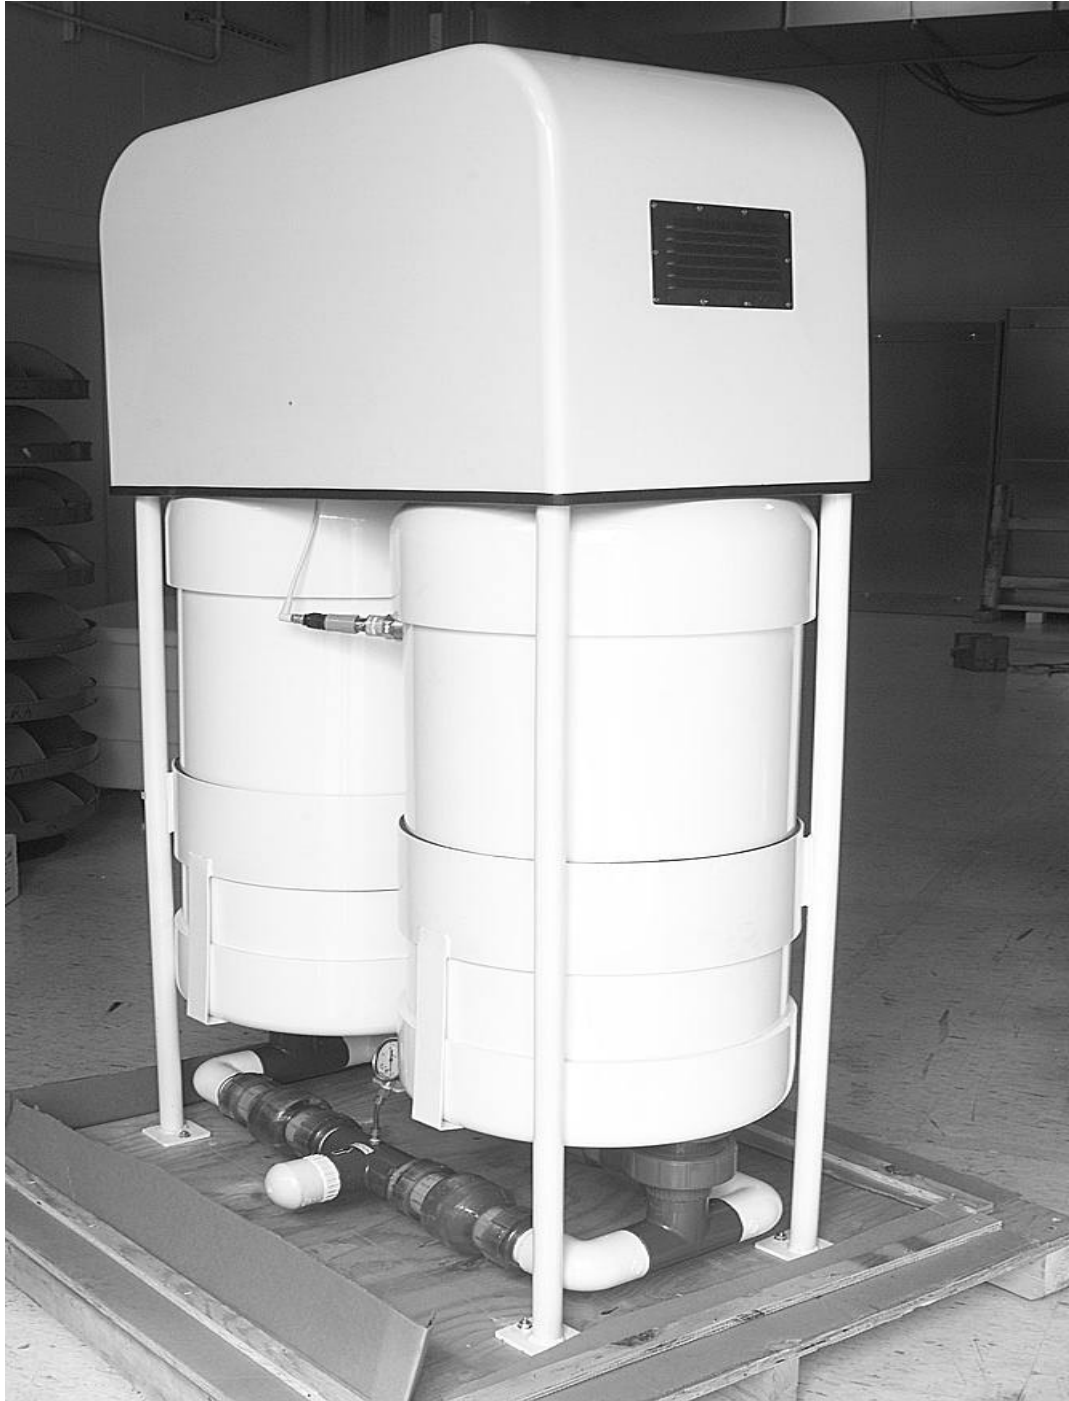
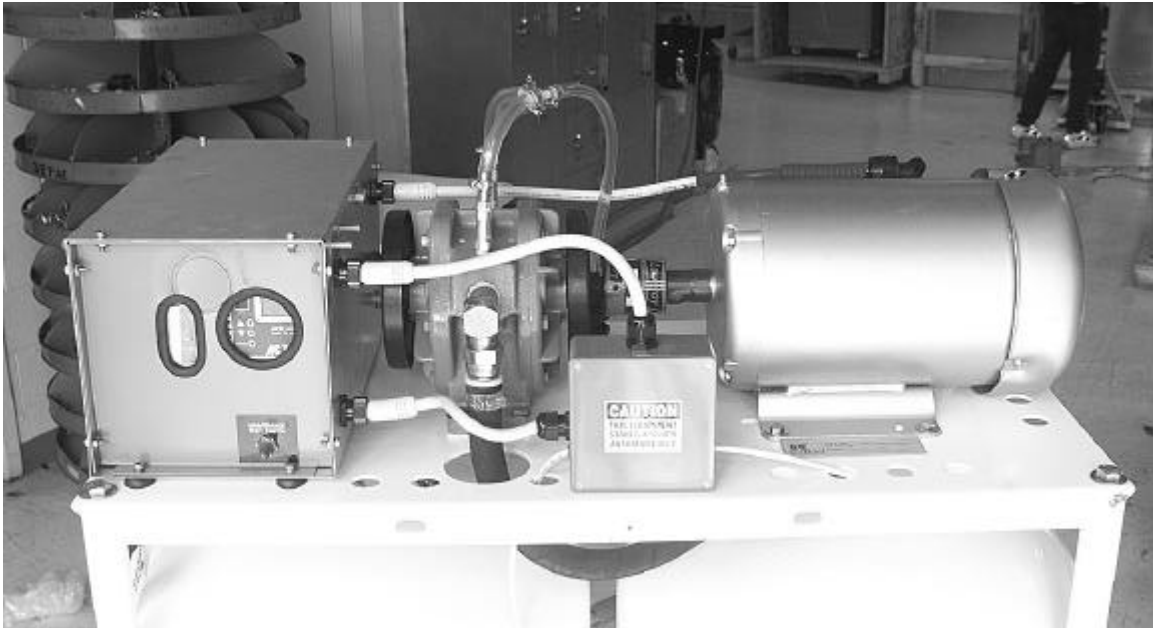
Unit Photographs

1. The unit shut down two times on the F1 Fault on the control system. The F1 Fault is described in the Keco Product Guide as: “EPM Fault: The EPM is missing or damaged”. Keco was contacted and indicated that the source of the problem was most likely a loose EPM chip in the control circuit. Keco recommended reseating the EPM chip on the front panel of the control unit. For each F1 Fault, the EPM chip was reseated by hand by pressing in on the cover of the EPM chip on the front panel of the control unit. Power to the unit was cycled by opening and closing the circuit breaker for the unit, and the failure code was cleared from the control system. The unit was restarted and exhibited normal operation.

2. The unit shut down once and dashed lines were displayed on the control unit display. Keco was contacted and recommended cycling power to the unit to clear the failure code on the control system. The reason for this shutdown was not able to be determined, but it was most likely caused by a logic error in the Programmable Logic Controller (PLC). The power to the unit was cycled by opening and closing the circuit breaker for the unit, and the unit was restarted, however, it exhibited the same shutdown within a few minutes of operation. The power to the unit was cycled again by opening and closing the circuit breaker for the unit, and the unit was restarted and exhibited normal operation.

3. Both transfer tanks on the unit had to be replaced after approximately 450 hours of operation in the life-cycle testing set-up, because both tanks developed cracks on the bottom around the outer edge of the cylindrical tank. Keco was consulted regarding the failure of these tanks, and they believe that the ambient temperature during life-cycle testing probably contributed to the failure. The Keco Product Guide for the unit indicates that stainless steel tanks are strongly recommended for cold weather locations (below 45 degrees Fahrenheit). Life-cycle testing was conducted through the winter months at temperatures below 45 degrees Fahrenheit for considerable time periods during life-cycle testing. The life-cycle testing set-up was shutdown during the winter months when temperatures dropped below 32 degrees Fahrenheit to prevent freezing of the media in the piping.

4. The unit began to exhibit episodes of intermittent running after the first tank was replaced, and the problem could not be resolved by cycling power to the unit. After consulting Keco, the control unit was changed out with a spare control unit and life-cycle testing was continued. Keco performed troubleshooting on the original control unit and the problem was identified to be a defective EPM chip in the control circuit.

1. Corrosion Resistance: A sample of the metal frame that supports the plastic tanks was subjected to the Salt-Spray Exposure described in *Section 2.3*. The sample was found to have inferior corrosion resistance. The sample displayed pronounced corrosion on bare metal surfaces of the sample. The painted surfaces of the metal sample also exhibited corrosion under the surface of the paint.
 2. Ultraviolet Exposure Resistance: A sample of the Molded Solid Fiberglass Cover for the unit was subjected to the Ultraviolet Exposure described in *Section 2.4*. The sample was found to have superior resistance to fading, cracking, and discoloration due to simulated exposure to sunlight and moisture.
-

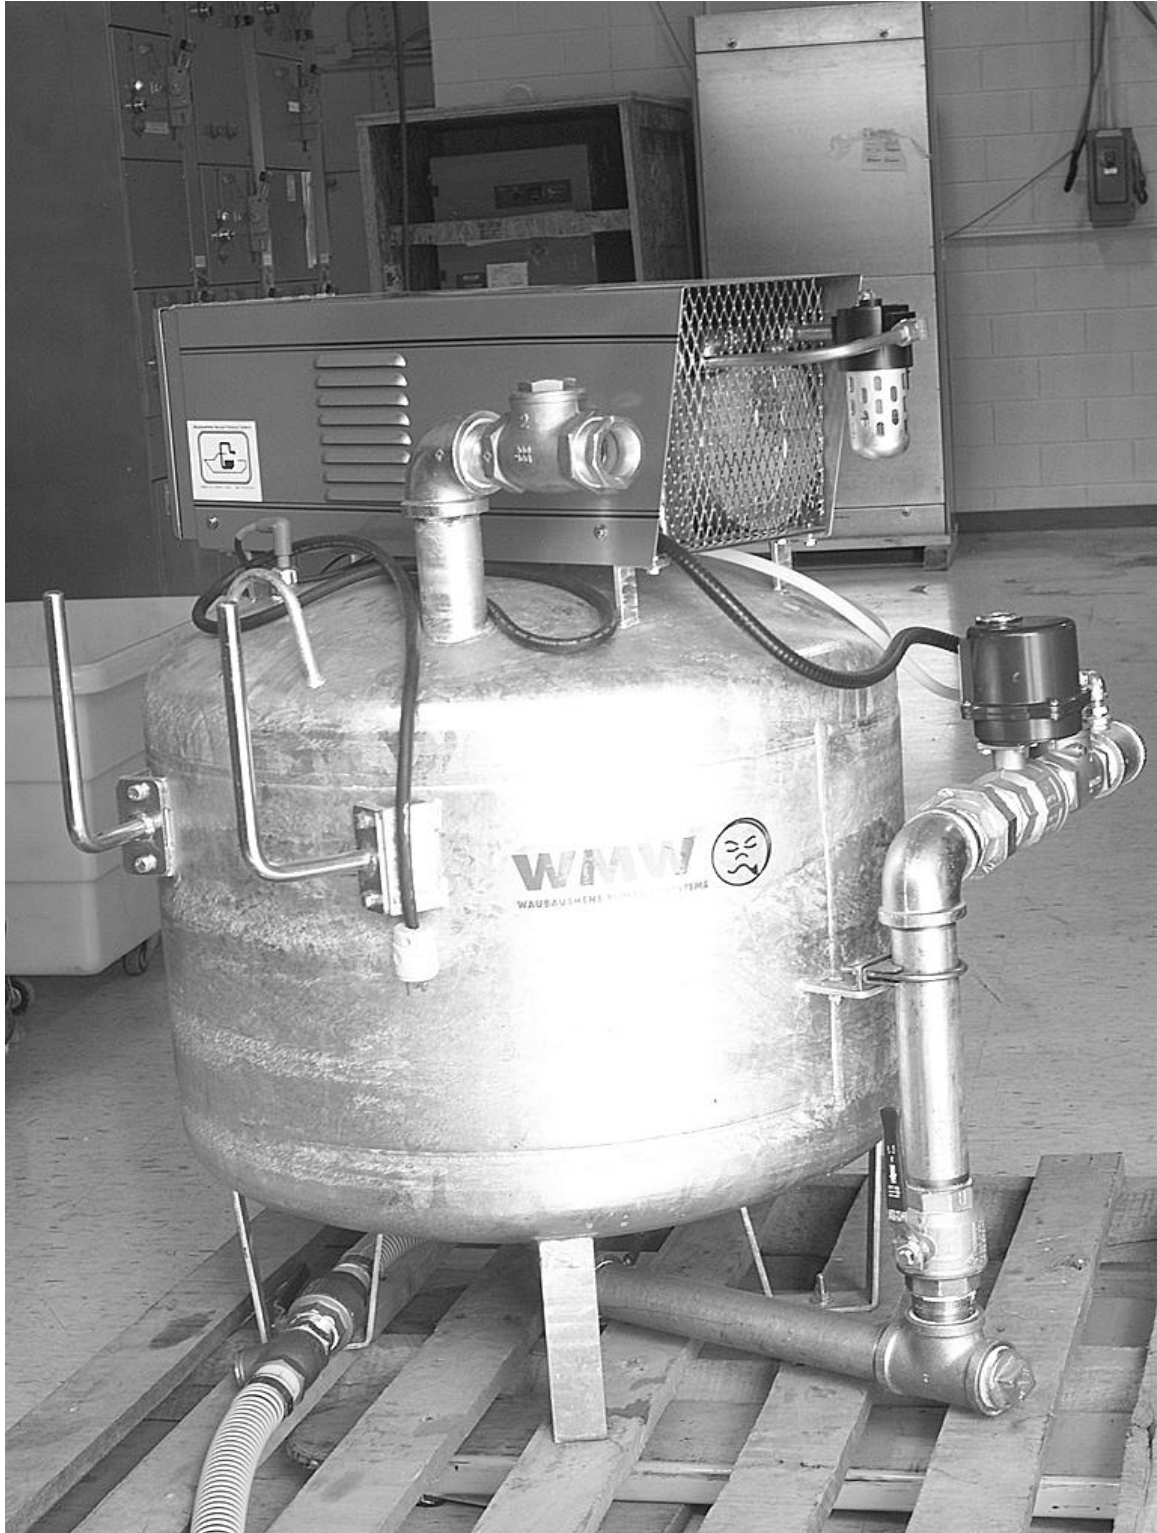
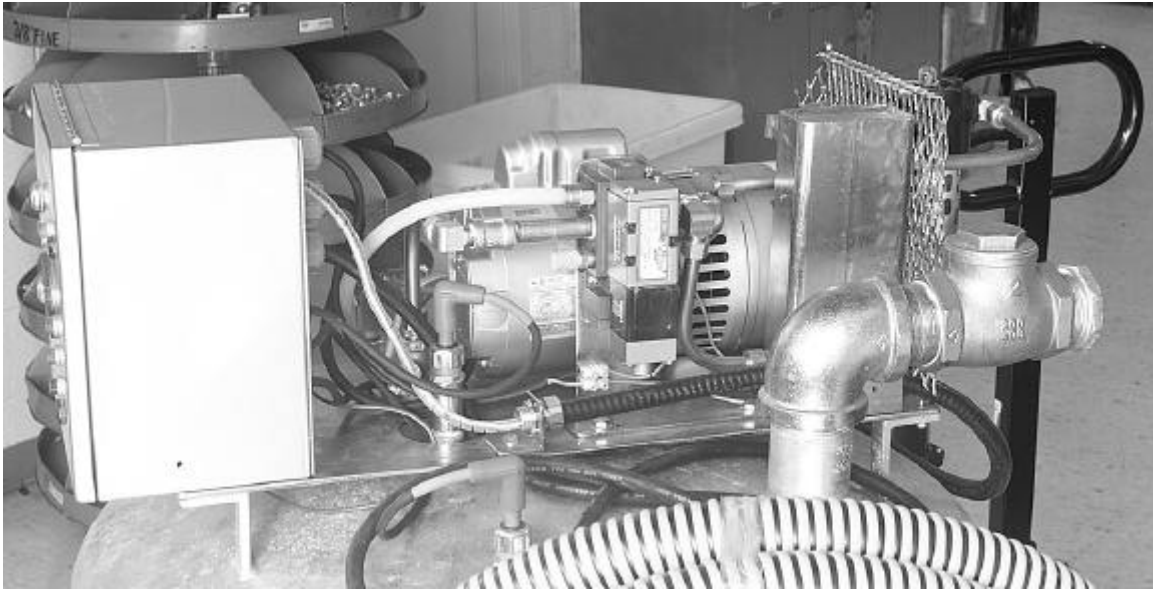
Unit Photographs

1. The unit was initially found with the circuit breaker tripped at 382.7 hours of operation. The unit was inspected and found to have no obvious problem, so the unit was restarted. The unit was monitored during operation and the vacuum pump was not drawing a vacuum on the transfer tank during the suction cycle. The unit was manually shifted to the discharge cycle and the vacuum pump would not produce pressure in the transfer tank. Waubaushene was consulted regarding this problem and suggested that this problem may be caused by the vanes in the rotary vacuum pump becoming stuck in place in the rotor of the pump. Waubaushene recommended opening up a port on the suction side of the vacuum pump and lubricating the pump with a lubricating oil (such as WD-40) to free up the stuck vanes. The vacuum pump was lubricated in this manner and the pump was
-

restarted in the life-cycle testing set-up. The unit operated for a short time and then tripped the circuit breaker again. On several occasions, the vacuum pump was lubricated and attempts were made to restart the unit. However, the unit continued to trip the circuit breaker. After further troubleshooting of the unit, the vacuum pump was found to stop operating prior to the circuit breaker tripping. Waubaushene was consulted and suggested that the problem may be overheating of the vacuum pump and electric drive motor. The electric motor that drives the vacuum pump has a thermal overload which is designed to interrupt power to the motor when the temperature of the motor is elevated sufficiently that damage might occur to the motor. The thermal overload will reset once the motor cools off, after being shut off for some period of time. In this case, the thermal overload was resetting after the pump cooled off, but the inrush of current when the motor was still at an elevated temperature was most likely tripping the circuit breaker. Waubaushene eventually recommended changing out the circuit breaker that was used to power the unit with another breaker of the same current rating, just to make sure that the circuit breaker was not the source of the problem. The circuit breaker was changed out with a spare breaker in the electrical panel and the unit continued to trip the circuit breaker during operation.

- When the vacuum pump problem was identified on the Chesapeake Bay Marine unit, the Waubaushene Model AVR60 was inspected to determine if the clogging problem, due to the lubricating oil encountered in the Chesapeake Bay Marine Vacuum unit, might be the cause of the frequent breaker tripping on the unit. The Waubaushene Model AVR60 vacuum pump is similar to the vacuum pump used on the Chesapeake Bay Marine unit and is produced by the same manufacturer (Gast). The vacuum pump discharge piping of the Waubaushene Model AVR60 was inspected and no deposits were noted. The clogging problem that occurred in the Chesapeake Bay Marine unit was most likely due to the low oil flowrate provided by the oiler. The Waubaushene Model AVR60 is equipped with an oiler with a higher oil flowrate than the Chesapeake Bay Marine and this difference in the units, most likely, prevented a clogging problem in the Waubaushene Model AVR60.

The painted steel cover sample exhibited inferior corrosion resistance. The sample displayed pronounced corrosion on bare metal surfaces of the sample. The painted surfaces of the sample also exhibited corrosion under the surface of the paint.

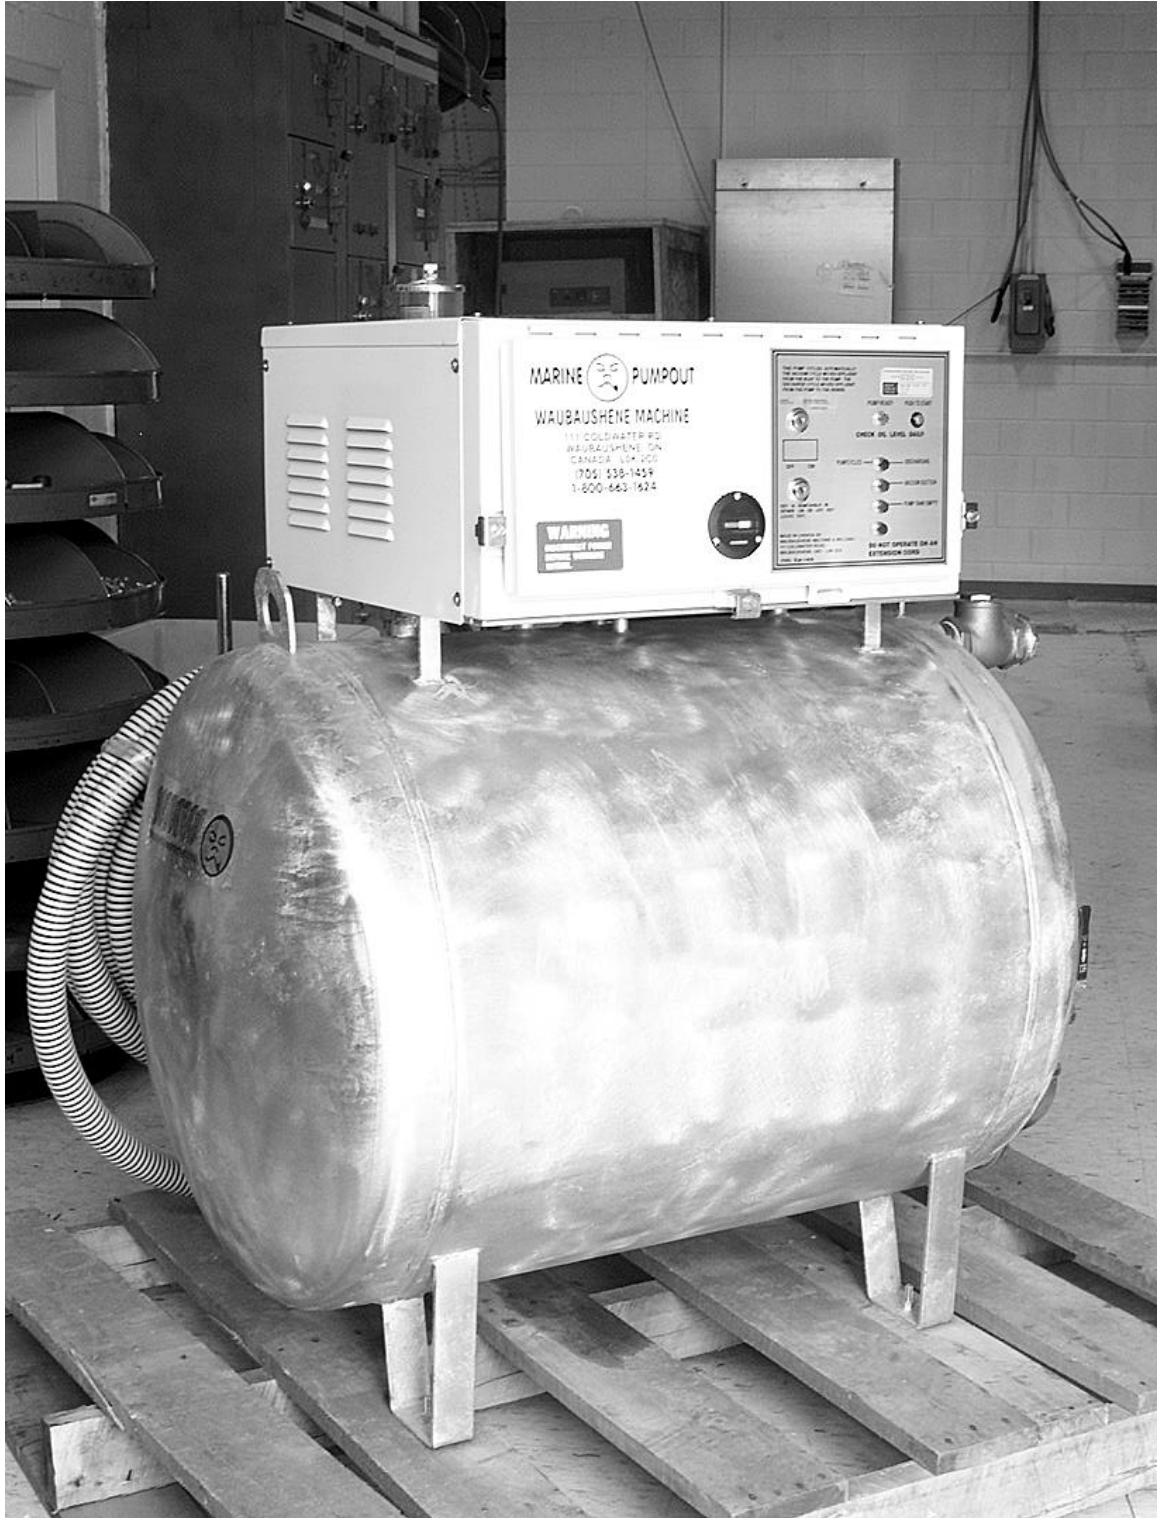
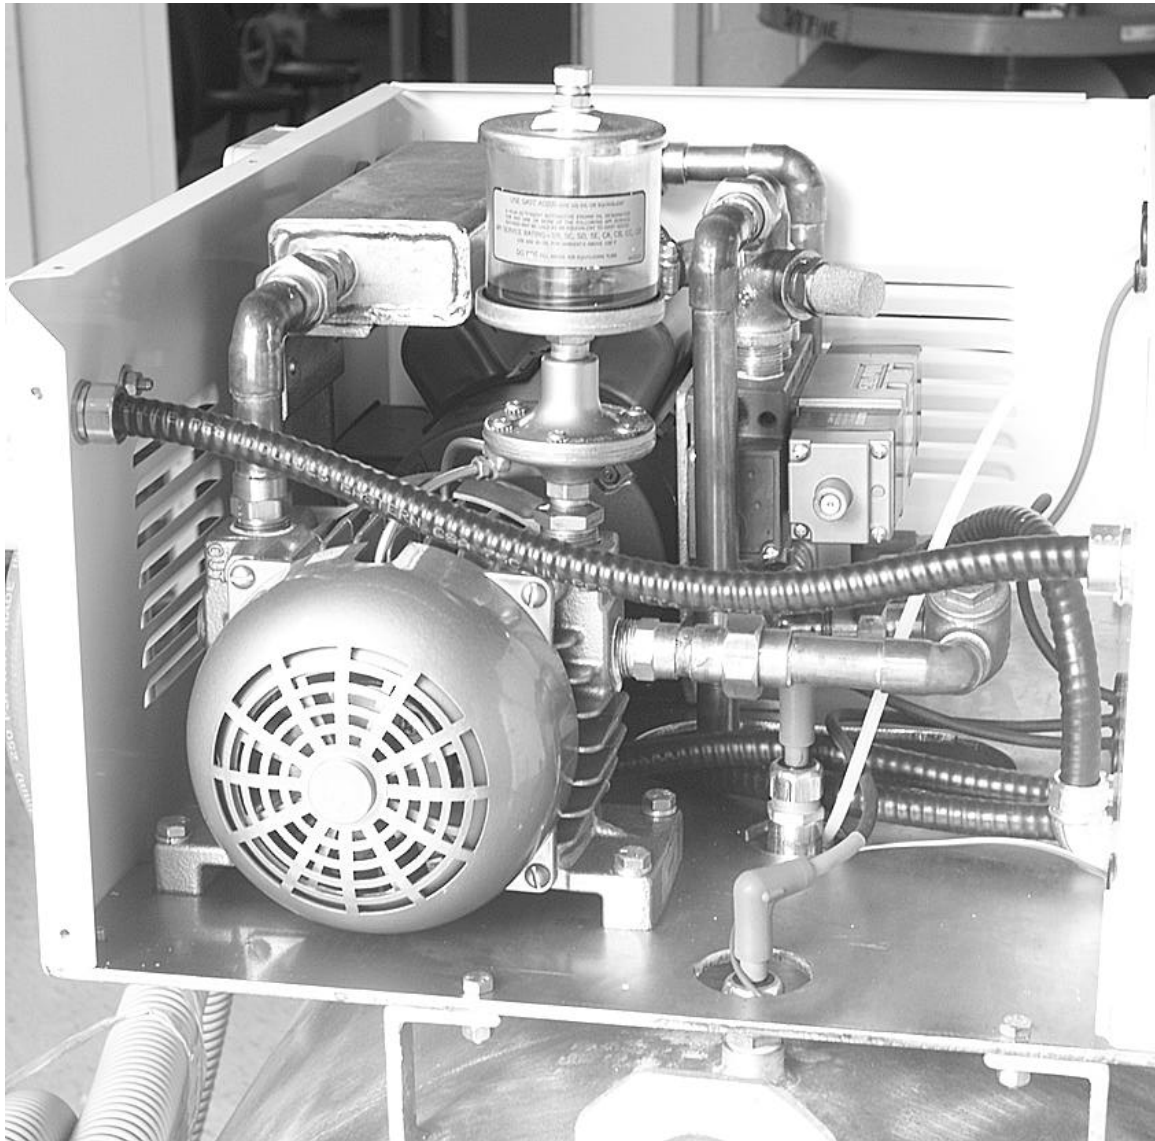
Unit Photographs

This unit was originally powered in the life-cycle testing set-up by a 30-Amp breaker with a Ground Fault Circuit Interrupter (GFCI). However, during initial test runs on the unit, the circuit breaker tripped several times during operation of the unit. After consultation with a UL electrical engineer, the most likely cause for these breaker trips was a phase imbalance between the line and neutral phases during operation of the unit. In order to continue with the life-cycle test program, the circuit breaker for the unit was changed out with a non-GFCI breaker. UL recommends that GFCI protection should be provided for every receptacle outlet and motor connection in every location where the environment might be wet, moist, or damp. Since this unit is used in an environment near water, and where operators of the unit could potentially be wet, the design of this unit should be evaluated and the phase imbalance that is present during operation should be eliminated, so the unit will operate with a GFCI breaker or GFCI receptacle outlet to ensure the safety of operators of the pump-out unit.

1. The pump was found operating with the spider coupling between the electric motor and the vacuum pump sheared out, so that the electric motor was disengaged from the vacuum pump and the motor was spinning freely. Troubleshooting revealed that the vacuum pump had filled with test media and was seized up (i.e. the pump shaft would not turn). Waubaushene was contacted regarding the problem and requested that the vacuum pump be shipped to their manufacturing facility for reconditioning.

2. Following reconditioning, the vacuum pump was reinstalled and the unit was restarted. The vacuum pump immediately started to make noise and the unit was shutdown again. Troubleshooting revealed that test media had again entered the vacuum pump, but this time the pump did not seize up. Waubaushene was contacted and suggested that the second failure of the vacuum pump was most likely caused by a failure of the air-reverse valve. Waubaushene recommended that the fuses in the air-reserve valve solenoid circuit be checked to see if the air-reverse valve was operating properly. A fuse was found to be blown in the circuit, so Waubaushene recommended cleaning the air-reverse valve assembly and replacing the fuse that was blown in the circuit. The air reverse valve assembly was disassembled and found to have test media inside the valve assembly (i.e. small pieces of toilet paper and sponge material). In addition, the vacuum pump had to be cleaned out and lubricated following the entry of test media into the pump, which was done this time by UL personnel. The unit was repaired and restarted.

3. The unit was found shutdown the next day with the circuit breaker tripped. Troubleshooting revealed that the unit was using very little oil out of the lubricating oil reservoir during operation. The oiler was removed and inspected for proper operation. No problems were identified with the oiler and the oiler was replaced and the unit was restarted.

4. The next day, the unit was found with the spider coupling between the vacuum pump and the electric motor sheared out again. Troubleshooting revealed that the vacuum pump had not seized this time but the pump shaft was rather difficult to turn by hand, so the pump was lubricated with oil to allow it to turn more freely. Waubaushene was consulted and concluded that the previous repairs were most likely caused by inadequate lubrication from the oiler on the unit. Waubaushene shipped a
-

- replacement oiler with a different design to modify the unit. The new oiler was installed and a new spider coupling was installed between the motor and the vacuum pump and the unit was restarted.
5. The spider coupling was found worn again the next day, this time due to the sprocket moving on the vacuum pump shaft, and allowing the spider coupling to become worn.
 6. Waubaushene was consulted regarding this failure and the decision was made to use Lock-Tite on the sprocket to keep it from moving on the vacuum pump shaft during operation.
 7. A replacement spider coupling was installed and Lock-Tite was applied to the vacuum pump shaft during reassembly to ensure that the sprocket remained fixed in place during pump operation and the unit was restarted.

The painted steel cover sample exhibited inferior corrosion resistance. The sample displayed pronounced corrosion on bare metal surfaces of the sample. The painted surfaces of the sample also exhibited corrosion under the surface of the paint.

After replacing the oiler with the new design and correcting the problem with the frequent failure of spider couplings, the unit operated in the life-cycle testing set-up for 128.7 hours without any additional problems being identified. Life-cycle testing was concluded on this unit on June 4, 2004. Some delays were encountered in repair of the unit during life-cycle testing that were not attributed to Waubaushene. The cold winter weather and the high volume of repairs required on other pump-out units in the study delayed the repairs outlined above for this unit.
