# PEPPERFIELD WETLAND ENHANCEMENT SUMMARY

PREPARED FOR: MARYLAND STATE HIGHWAY ADMINISTRATION  
BALTIMORE, MD

PREPARED BY: PARSONS BRINCKERHOFF  
BALTIMORE, MD

## Pepperfield Wetland Enhancement Project Summary

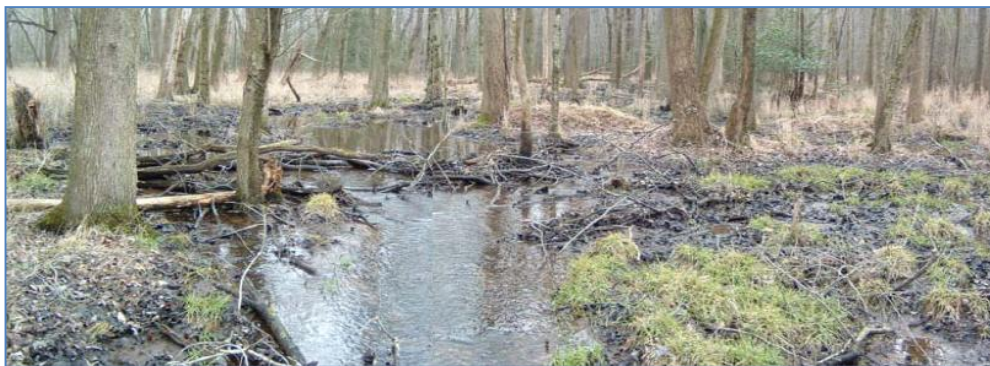
Figure 4: Klej Grange Wetland approximately 300 feet upstream of culvert (February 2005)

The project site is composed entirely of Forest and Forested Wetlands. A 4' by 6' elliptical corrugated metal pipe located at the downstream end of the study area carries the Rayfield Ditch flow beneath Klej Grange Road. It appears that the culvert has caused a backwater condition which has led to the creation of a forested wetland immediately upstream of the roadway. (Stations 27+50 to 30+50) Figure 4 shows a picture of the forested wetland area.

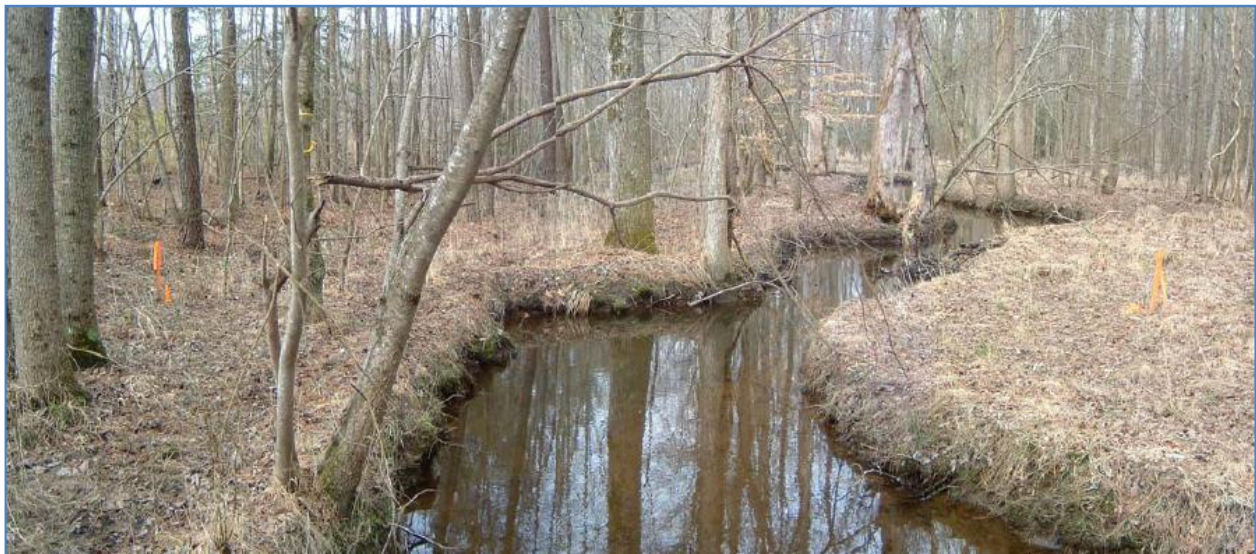
Figure 6: Approximately 900 feet upstream of Klej Grange Road (February 2005)

The channel becomes more entrenched and less connected to the floodplain as it moves upstream. The channel narrows and frequently has vertical or undercut stream banks. Figures 6 through 9 show the progression of channel incision and disconnection to the floodplain as the channel moves away from the Klej Grange culvert.

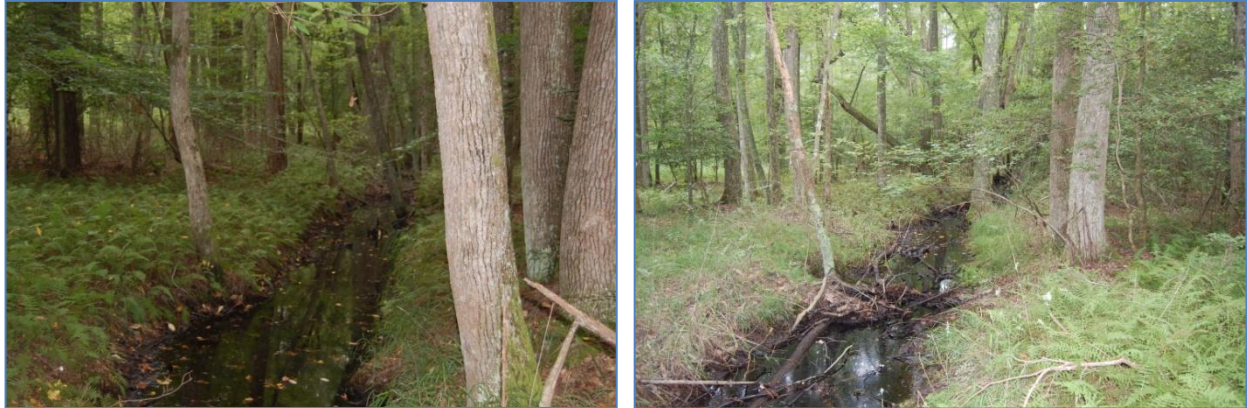
Figure 10: Existing conditions of Rayfield Ditch Tributary (August 2009)

The Rayfield Ditch Tributary flows north of the Rayfield Ditch and joins the mainstem just prior to Klej Grange Road. The tributary has better connection to the floodplain than the mainstem, it was determined that the installation of a series of log drop structures could encourage the development of forested wetlands in the area similar to those near Klej Grange Road.

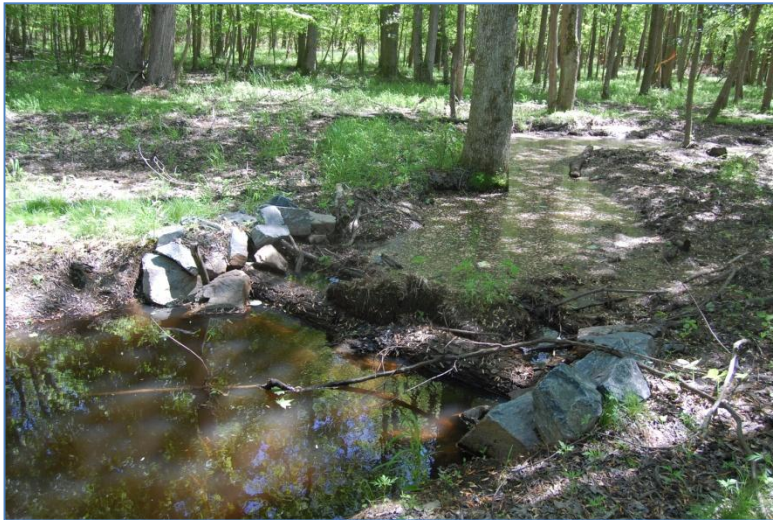
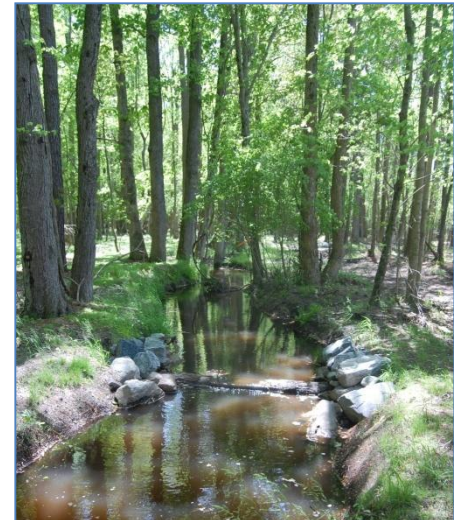
Figure 11: Log drops #3 and #14 (April 2010)

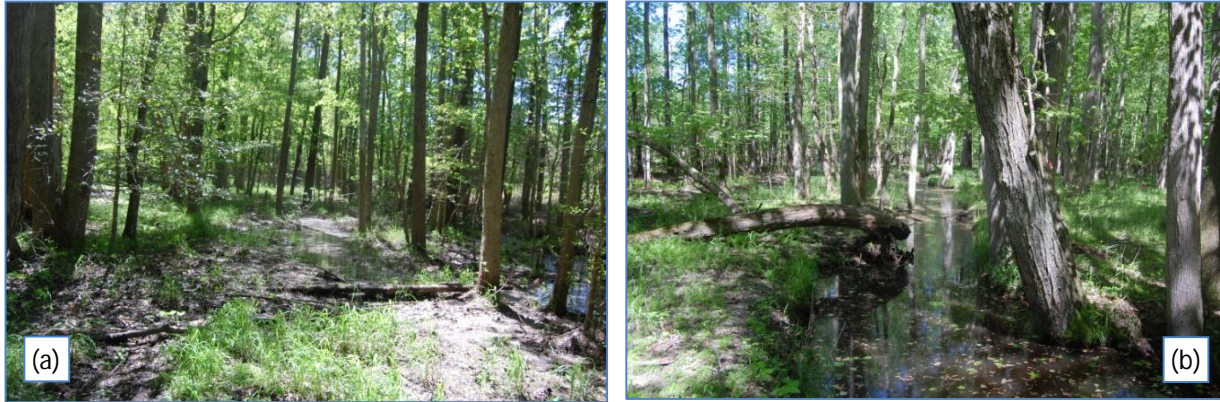
Figure 12: (a) Looking at left floodplain between log drop #2 and #3. Notice sediment deposition along left banks indicating frequent overbank flows. (b) looking downstream between log drops #14 and #1. Notice sediment in overbanks and depth of flow in channel. (April 2010)

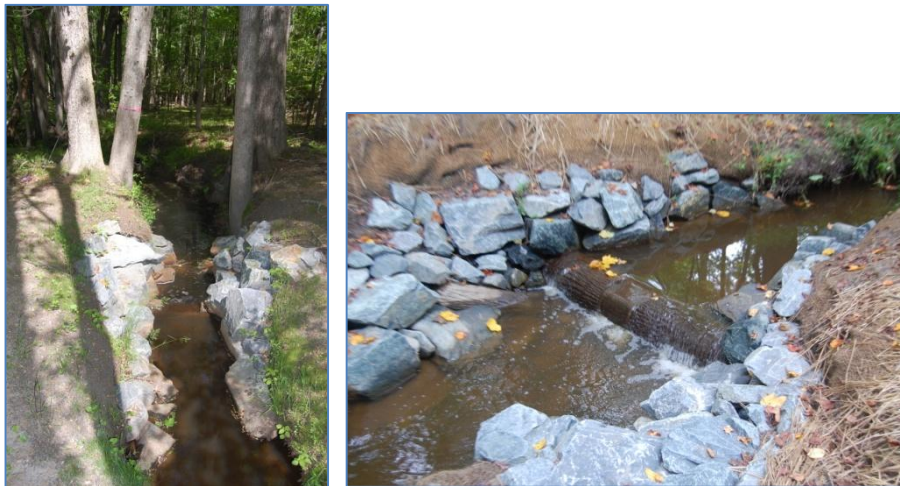
Log vane #3 was converted to a log drop in the field because of the large trees in the vicinity of the channel. Several large trees would have needed to be removed to install the vane and it was determined that installing a log drop in this location would meet the design intent of the plan while preserving the mature trees.

Figure 13: "Log vane 3" converted to log drop (April 2010 on left and August 2009 on right)

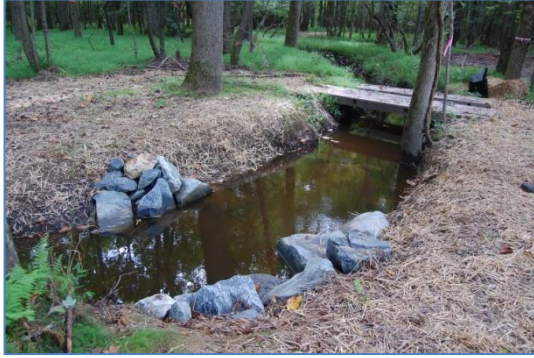
Figure 14 shows the downstream most log vane (#7). The figure shows that the vane is submerged due to the backwater from the downstream log drops. Although this structure is not functioning as designed, it was left in place because it will still help control grade and direct flows during larger storm events.

Figure 14: Log vane #7 is buried due to back water from downstream log drops. (August 2010)

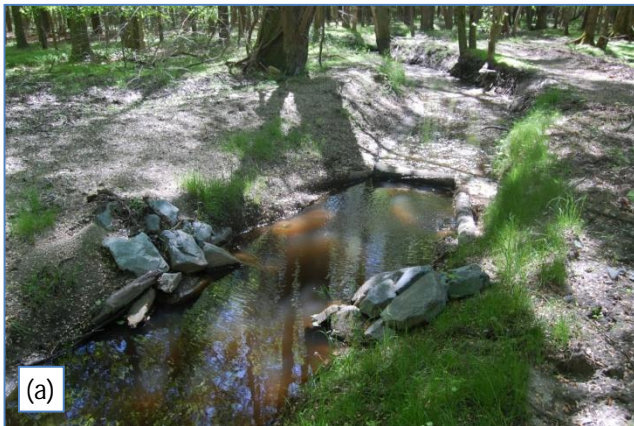
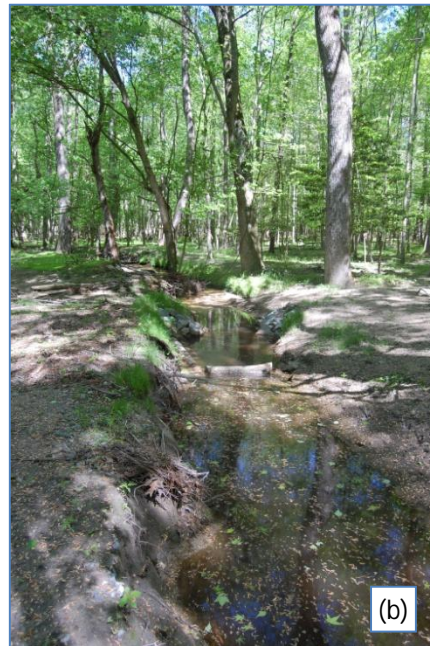
Figure 15: Log vane #6 (a. looking upstream, b. looking downstream), notice the significant amount of deposition in the floodplain. (April 2010)

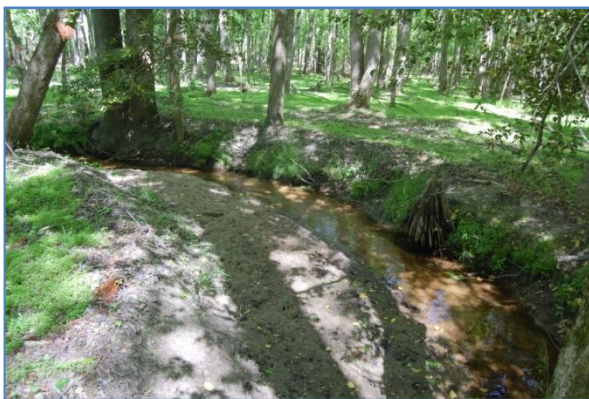
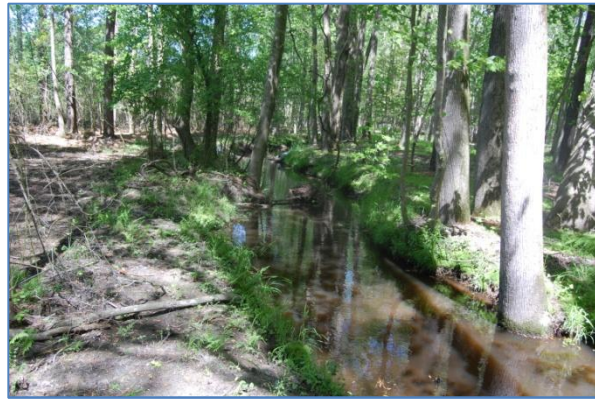
Figure 16: Bar formation and channel deposition between log vanes #6 and #7 (April 2010).

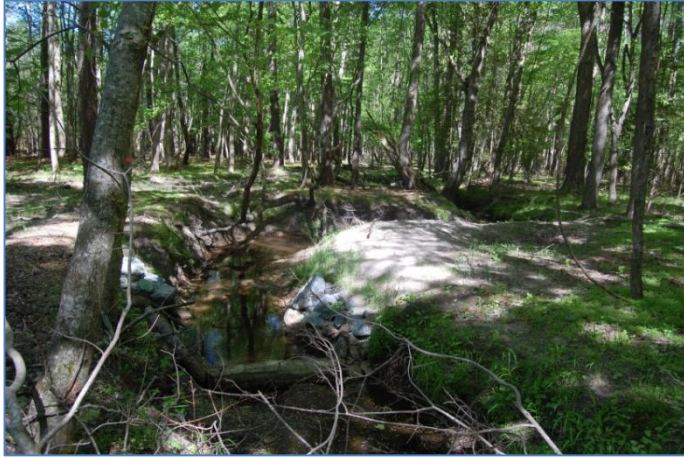
Figure 17: Looking downstream at log vane #4. Notice deposition along both stream banks.

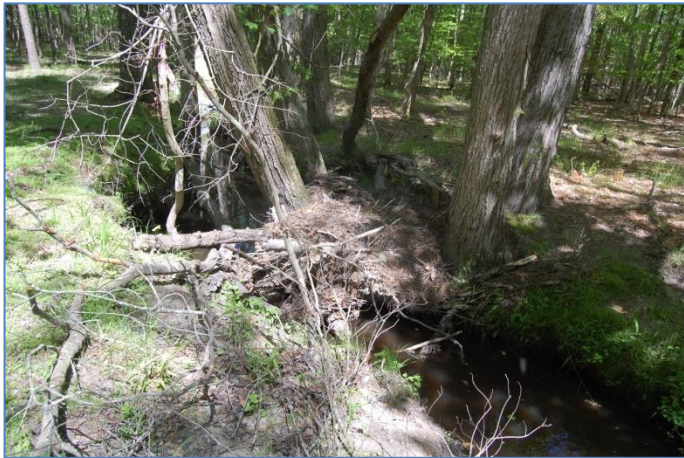
Figure 18: Debris jam between log vanes #2 and #3. Notice the height of debris above the flow. This indicates the flows are frequently overtopping the banks. (April 2010)

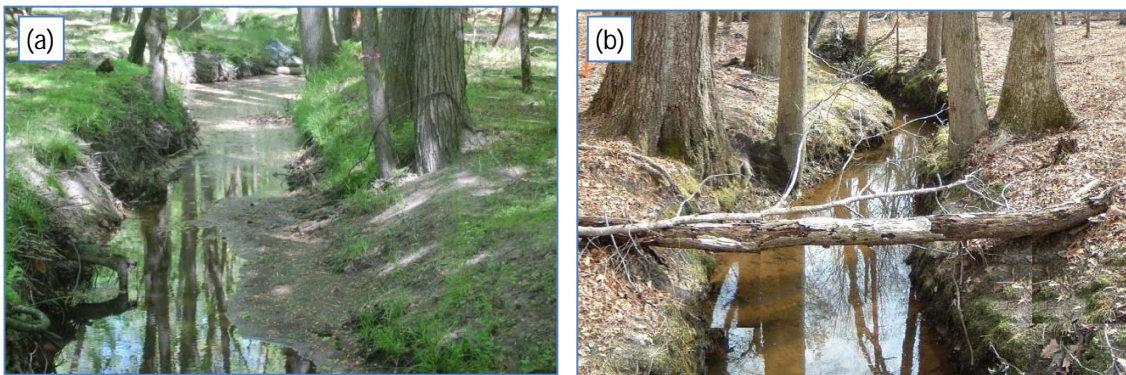
Figure 19: (a) Bar formation and deposition between log vanes #1 and #2 in April 2010. (b) Same section of stream in 2005.

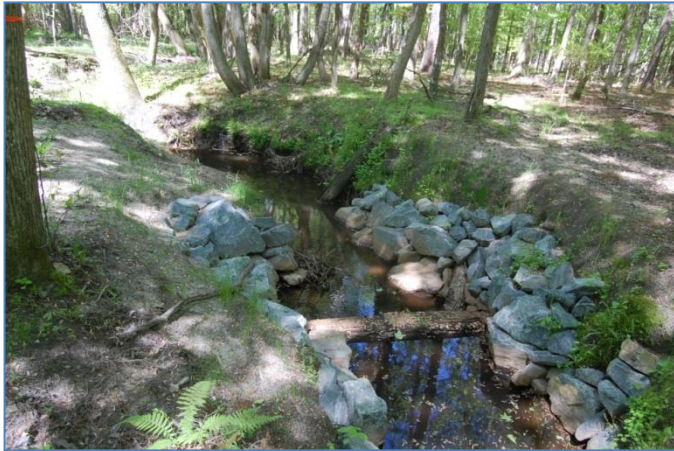
Figure 20: Looking downstream at modified log vane #1. Notice deposition along banks. (April 2010)

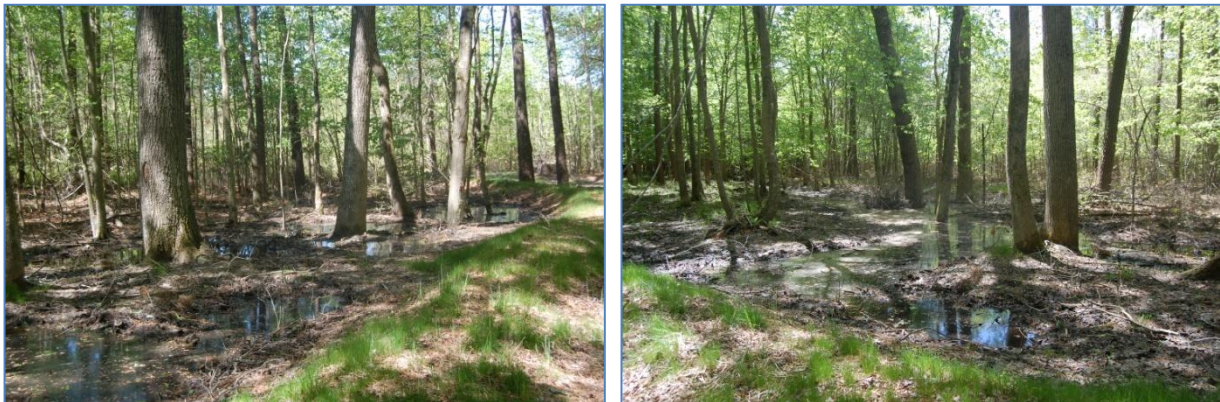
A level spreader was installed on an unnamed tributary to disperse flows before reaching Rayfield Ditch. Figures 21 and 22 show examples of the forested wetlands that have developed as a result of the flow blockage.

Figure 21: Forested wetland upstream of level spreader (April 2010).

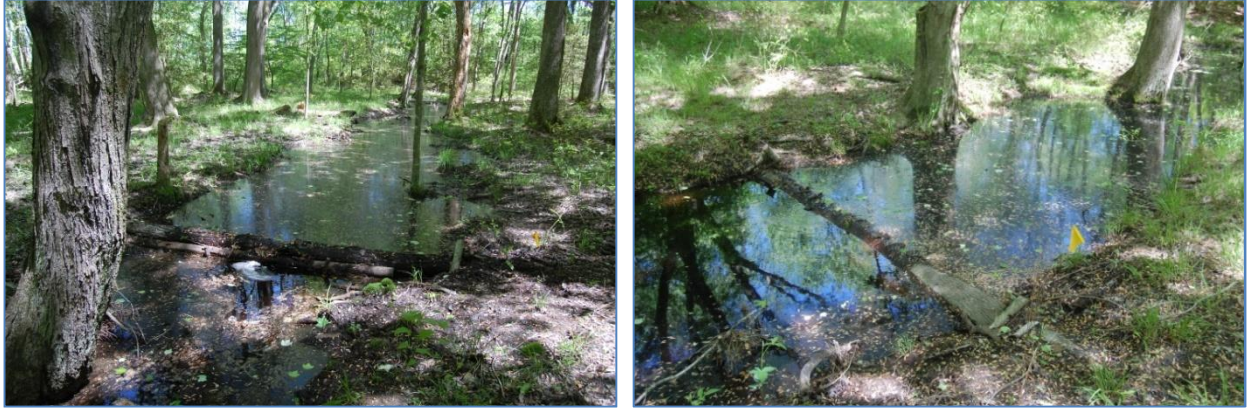
**Figure 22: Downstream most log drops (April 2010)**

The proposed log drop structures were modified to minimize disturbance of existing wetlands during construction. By eliminating the footer and drop logs in many cases and utilizing smaller diameter logs, smaller equipment was able to be used which allowed the contractor to stay away from adjacent wetlands. The number of proposed structures remained the same (10 log drops); however, the structures were field located rather than at the stations noted in the design plans.
